CASE STUDY - EARLY DETECTION OF CORROSION IN JETTY LINES

JETTY LINE MONITORING

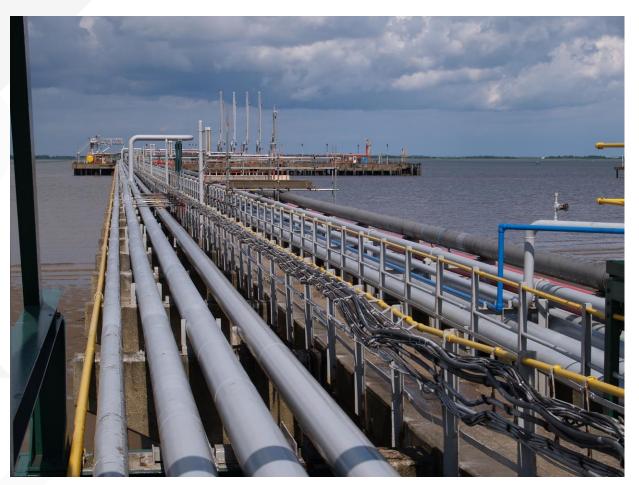
- Jetty facilities are critical operational elements of sea-borne refineries, enabling import of crude and feedstocks and export for finished products and intermediates.
- Often a considerable distance out from the shore to enable safe berthing of vessels to load/unload, so the various pipelines from the refinery to the jetty can be several kilometres long.
- The pipelines are exposed to severe weather conditions including sea spray, increasing the possibility of external corrosion in addition to the corrosion from materials transported through the pipeline.

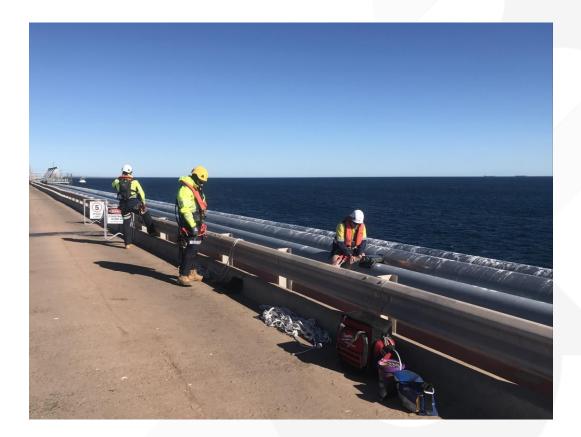
- Ensuring the integrity of these pipelines is a major challenge because access for regular inspections is difficult.
- Unplanned maintenance results in shipment of product by alternative means, resulting in a forced reduction in the refinery throughput or increased storage requirements.
- In addition to the operational and financial implications, any loss of containment may have serious environmental and reputational consequences.
- Proactive integrity management is therefore crucial for the safe and efficient transfer of fuel, chemicals, or other materials between ships and shore facilities.

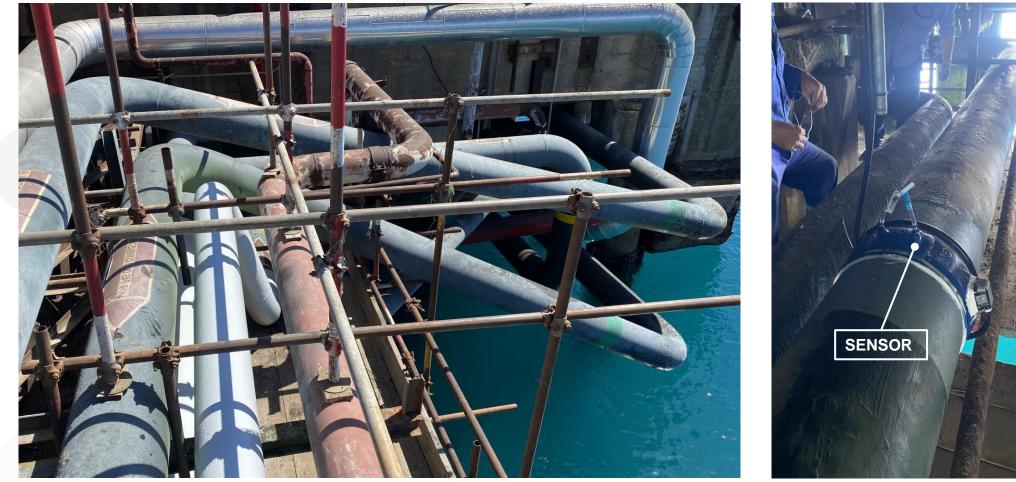
A client installed gPIMS monitoring sensors in 2022 on pipelines underneath and besides the jetty structure to assist with managing their integrity. The sensor installation on a 16inch crude oil line (12.7mm WT, corrosion allowance 3.17mm) used for this case study, located in an EX-area, is shown below.

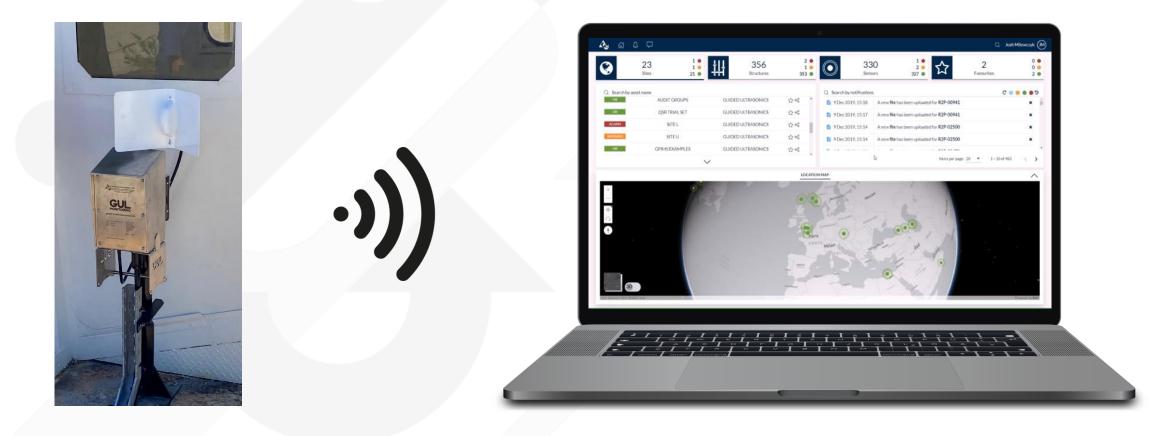
The system delivers frequent data via a Wi-Fi connection provided by field control units directly to the desk of the client's corrosion engineers. The information from the sensors is accessed via the browser-based **GUL Monitoring Studio**.

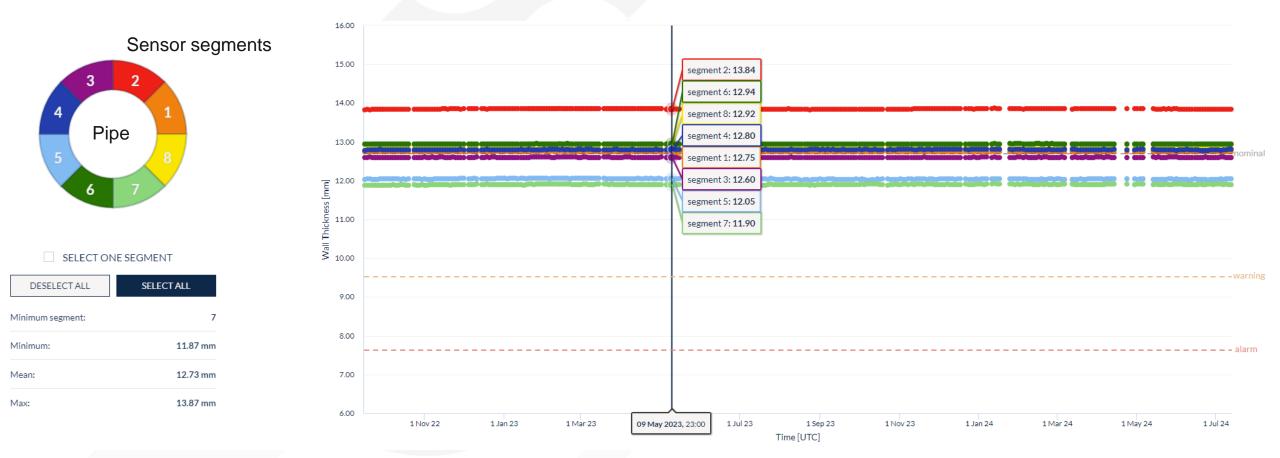
Wall thickness underneath the sensor location was stable throughout the period, showing there was no threat from generalized internal corrosion.

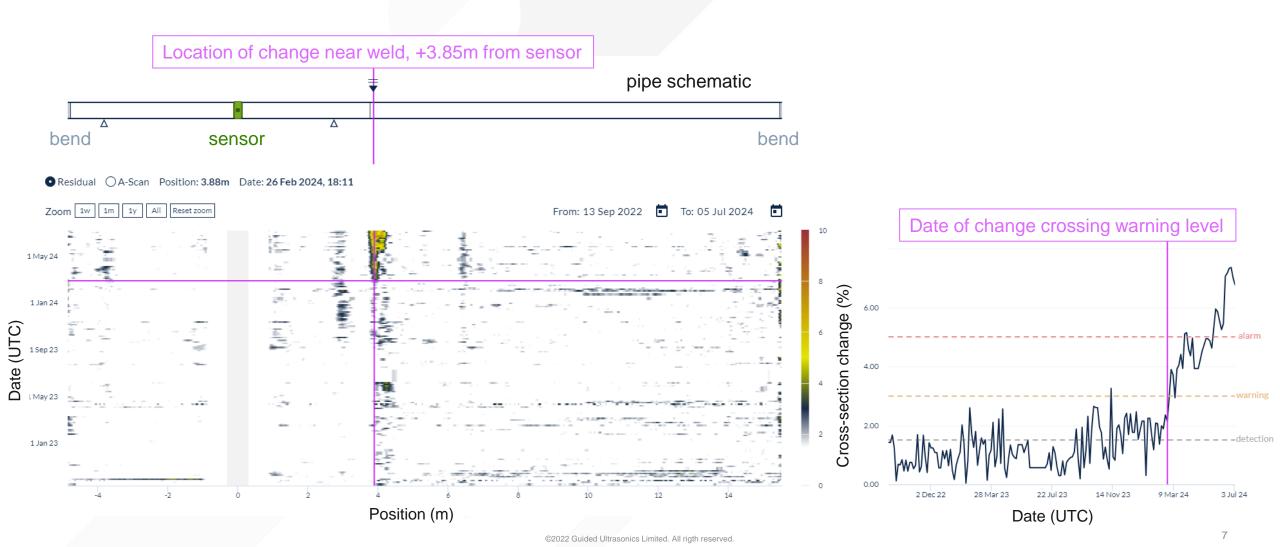
1.5 years after installation an alarm was raised in the Monitoring Studio on cross-section changes observed near a weld.

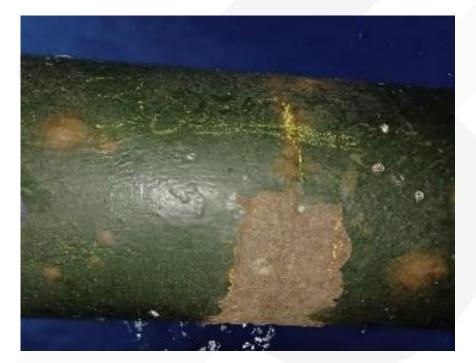
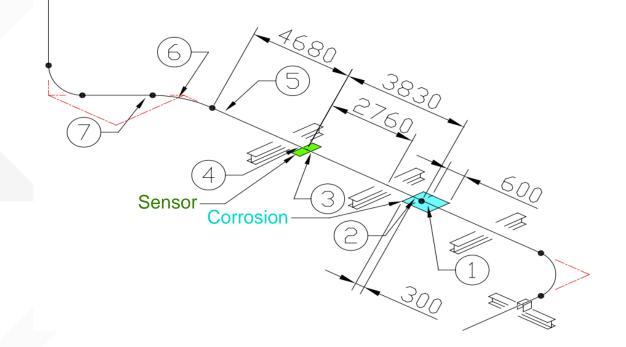
Visual follow-up inspection revealed corrosion scale in the area of the weld. The scale was removed and the area around the weld inspected:

Visual testing: ~ 1-3mm wall loss in the affected area

Ultrasonic testing in area (1): minimum WT **10.8mm**; in area (2): minimum WT 11.2mm

- gPIMS monitoring allowed early detection of active corrosion before corrosion allowance limits were reached.
- The recommendation of the follow-up inspection was to clean the area affected and re-apply a coating suitable for marine environments. Therefore, more extensive, costly and unplanned maintenance, which could result in loss of profits from refinery operations due to restriction of jetty capacity, was prevented.
